# STATOR SERVICE ISSUES

PV500688

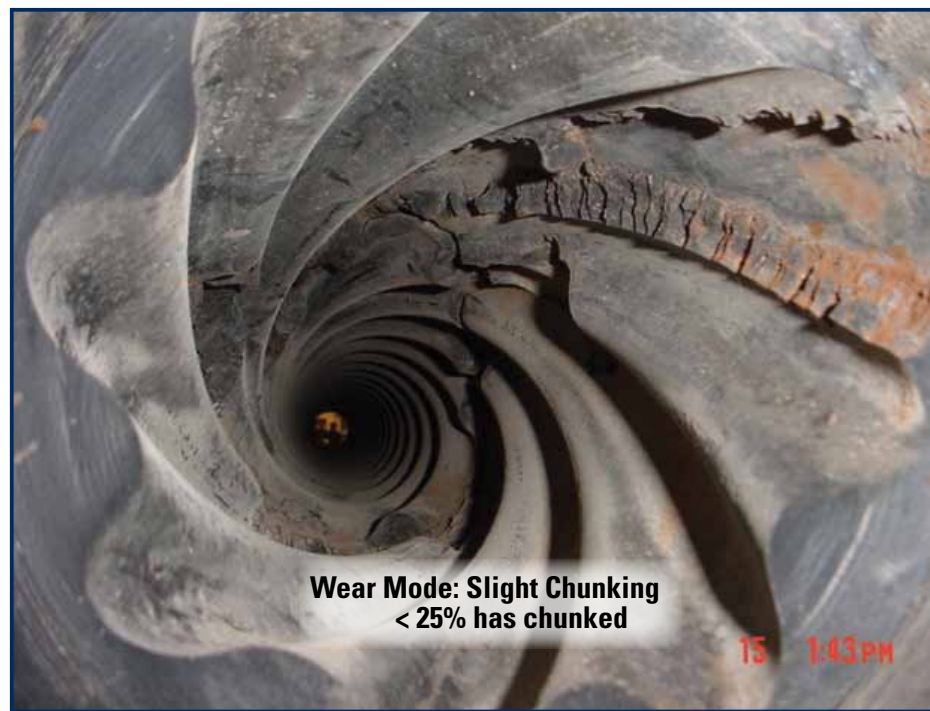
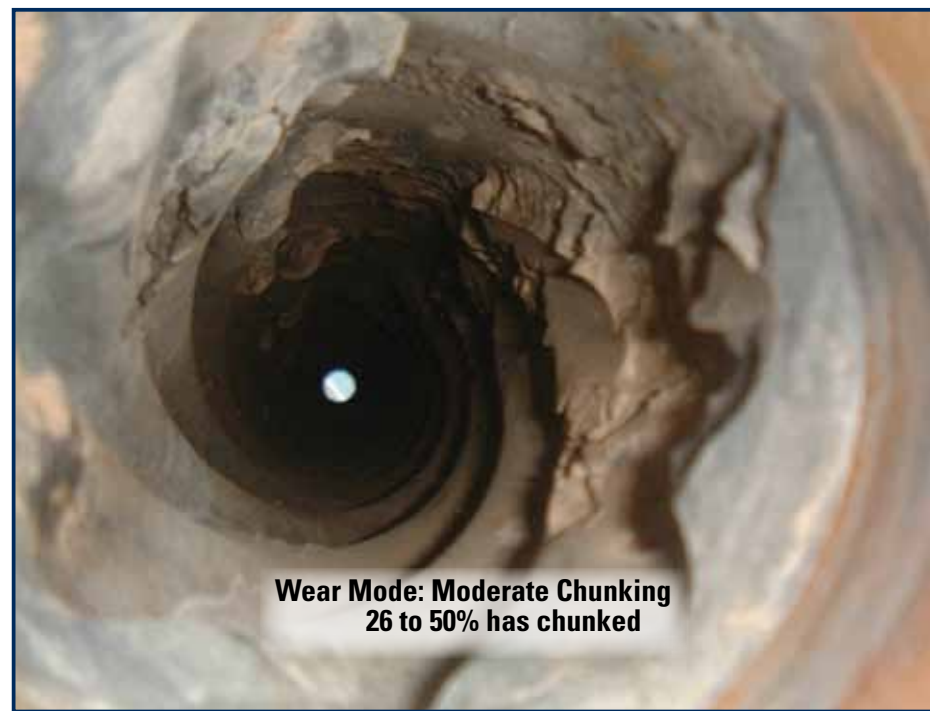
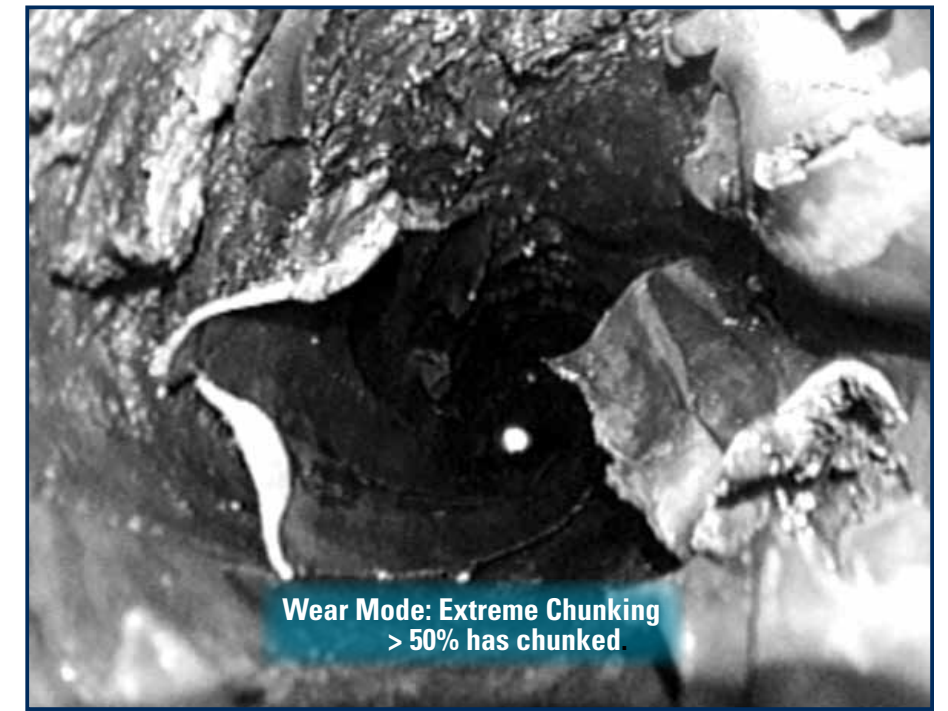
## Chunking Chunking Chunking

Chunking occurs when the elastomer has been over-loaded and has fatigued, tearing away from itself.

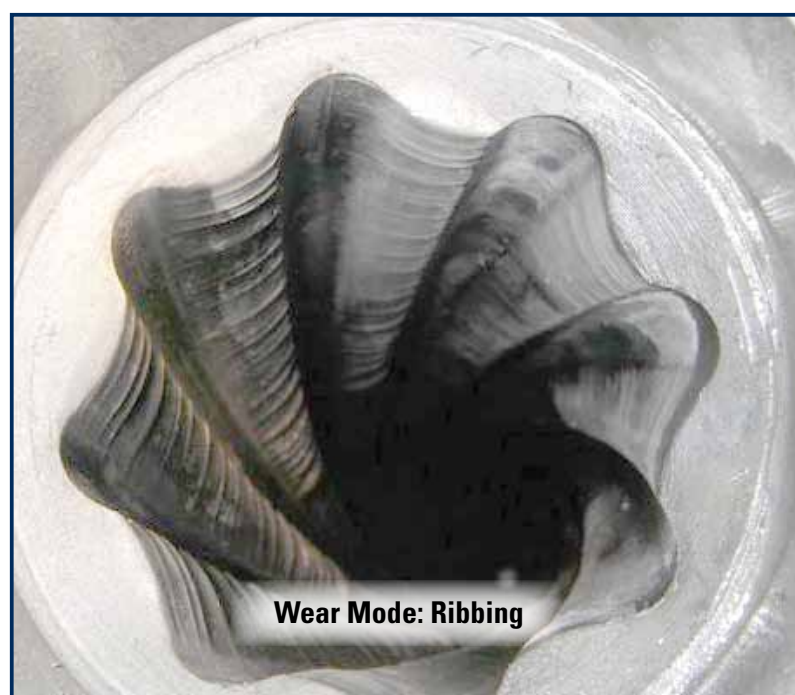
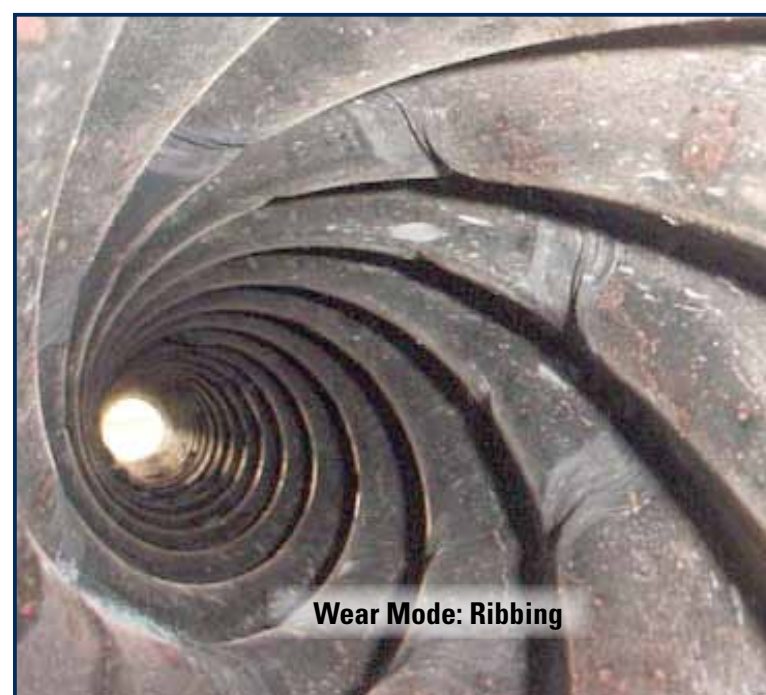
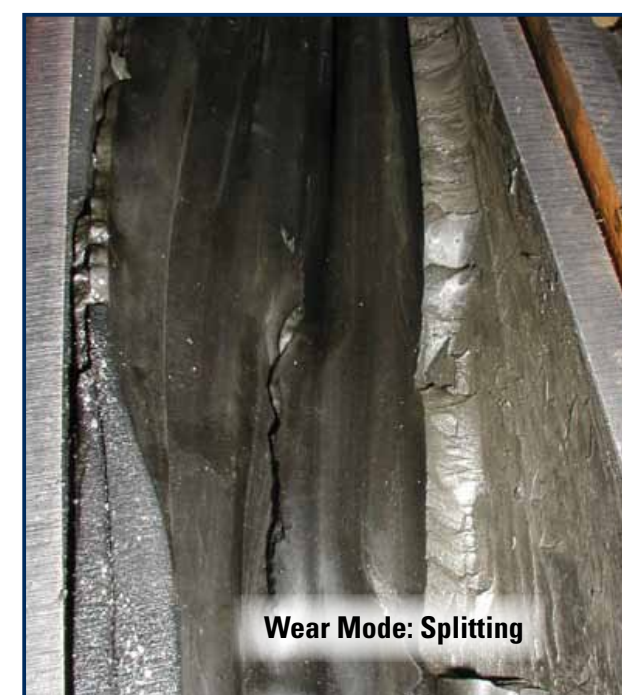
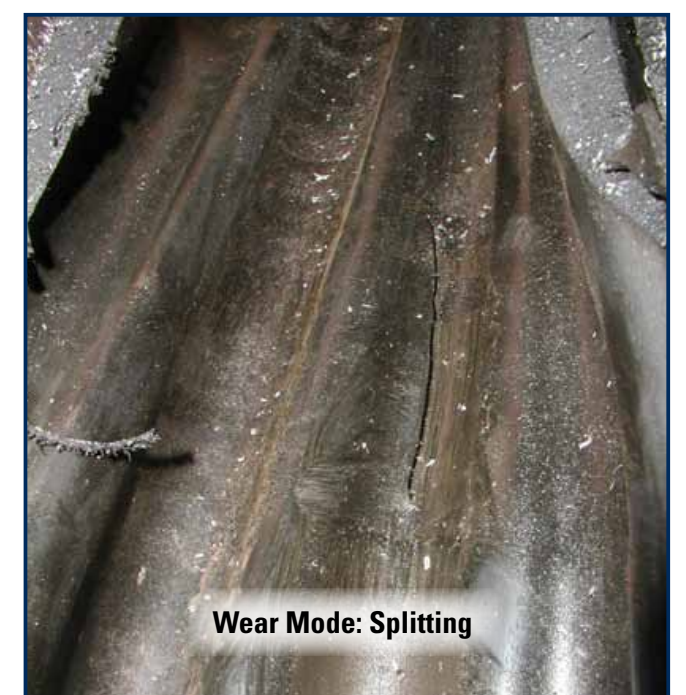
## Ribbing Ribbing

Ribbing is a mechanical type of failure where gouges, dents or depressions have been worn into the lobes.

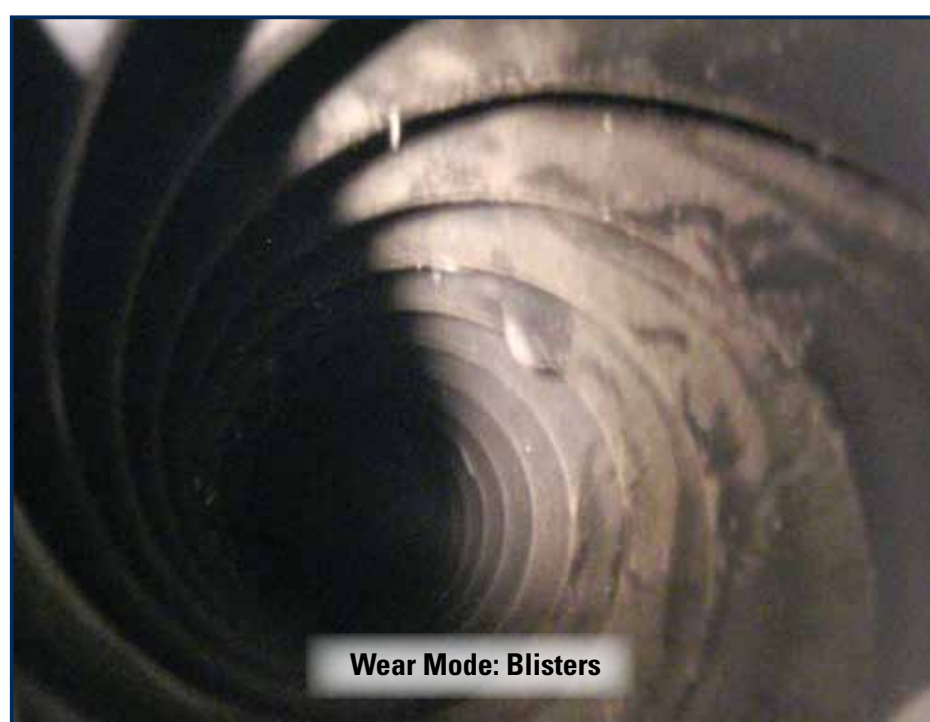
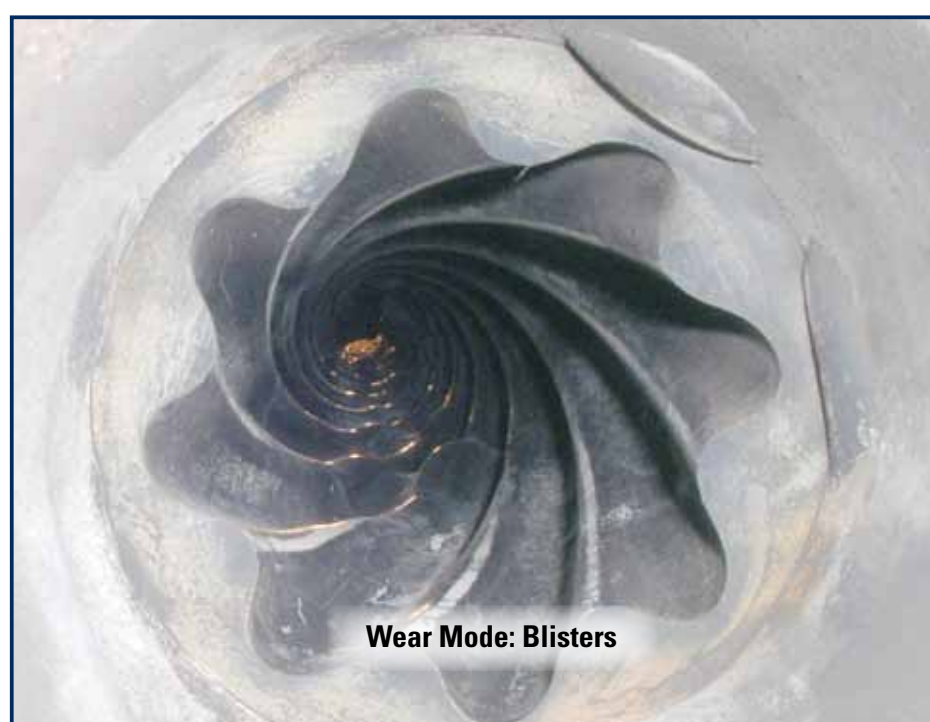
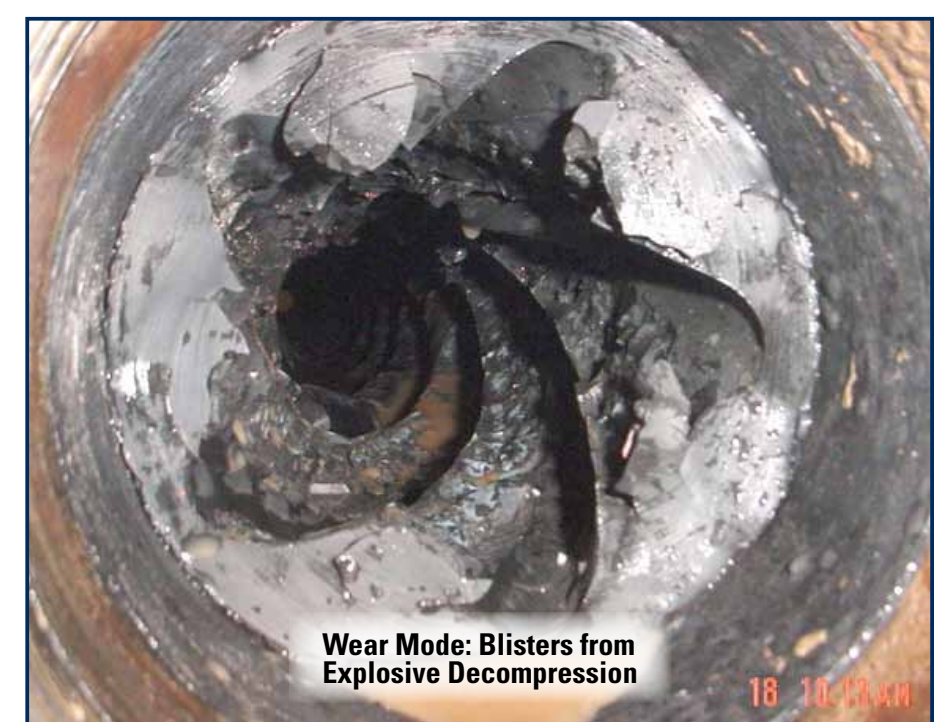
## Blisters Blisters Blisters

Air bubbles or "blisters" seen on the surface of the elastomer. They are caused by gas absorbed by the rubber under pressure and the pressure is released quickly, causing explosive decompression.

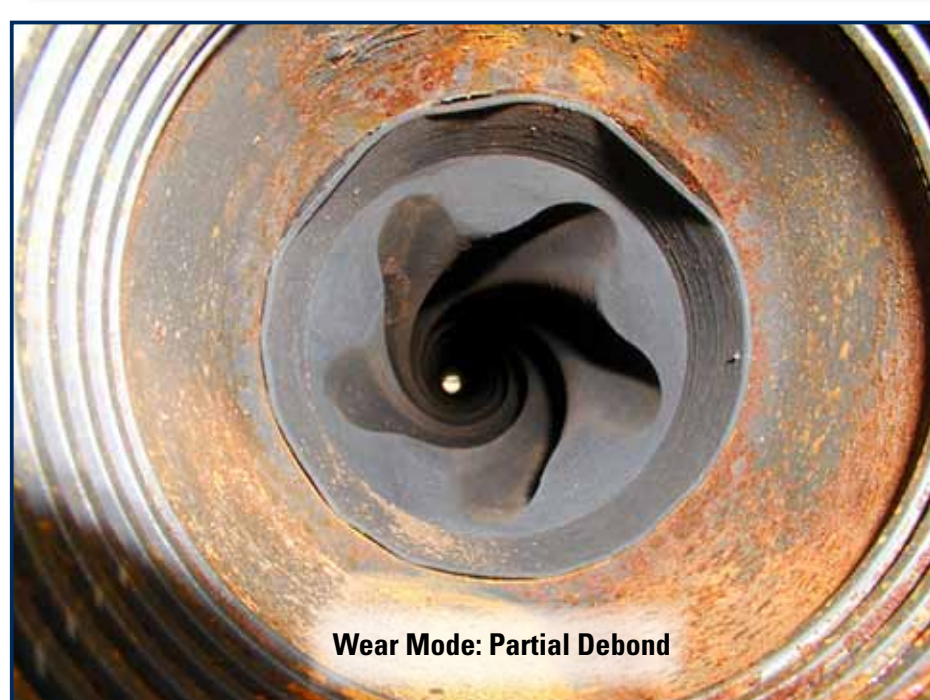
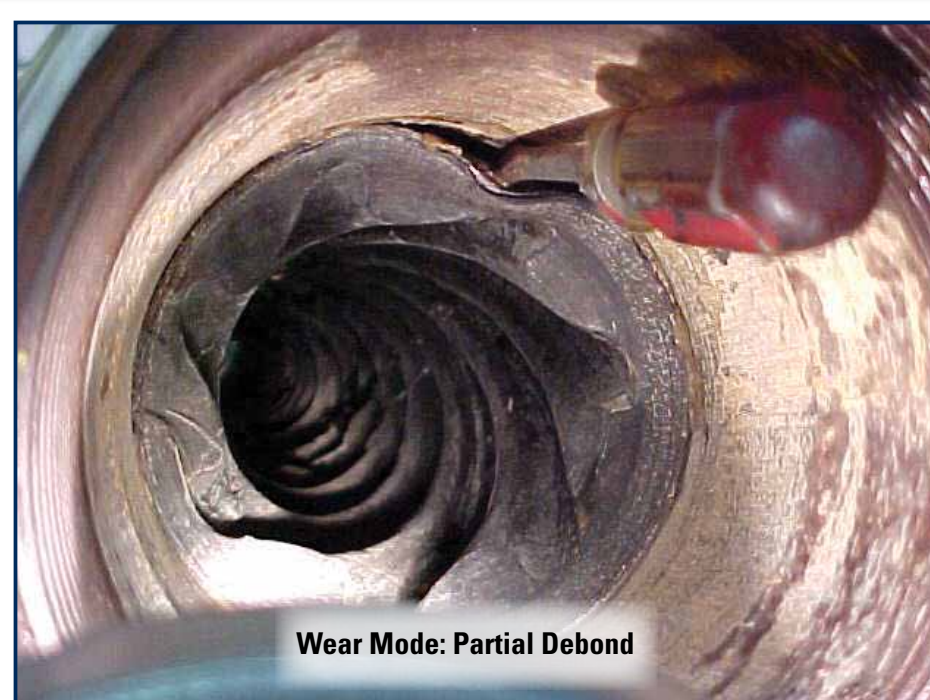
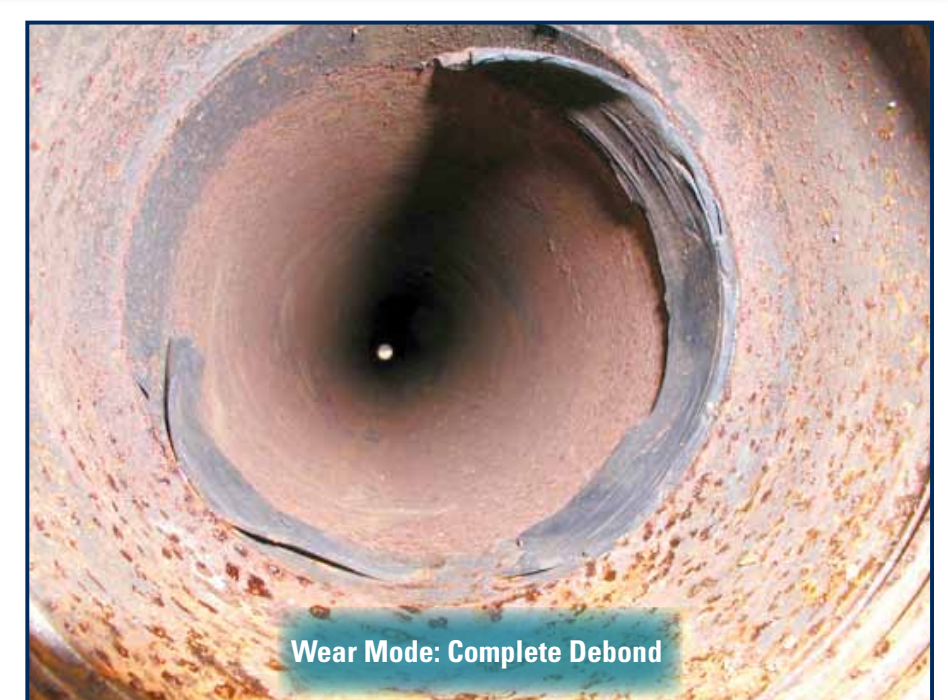
## Debond Debond Debond

Debonding is a failure of the adhesive between the rubber and the bond surface.
