ROTOR SERVICE ISSUES

PV Understands Rotors!

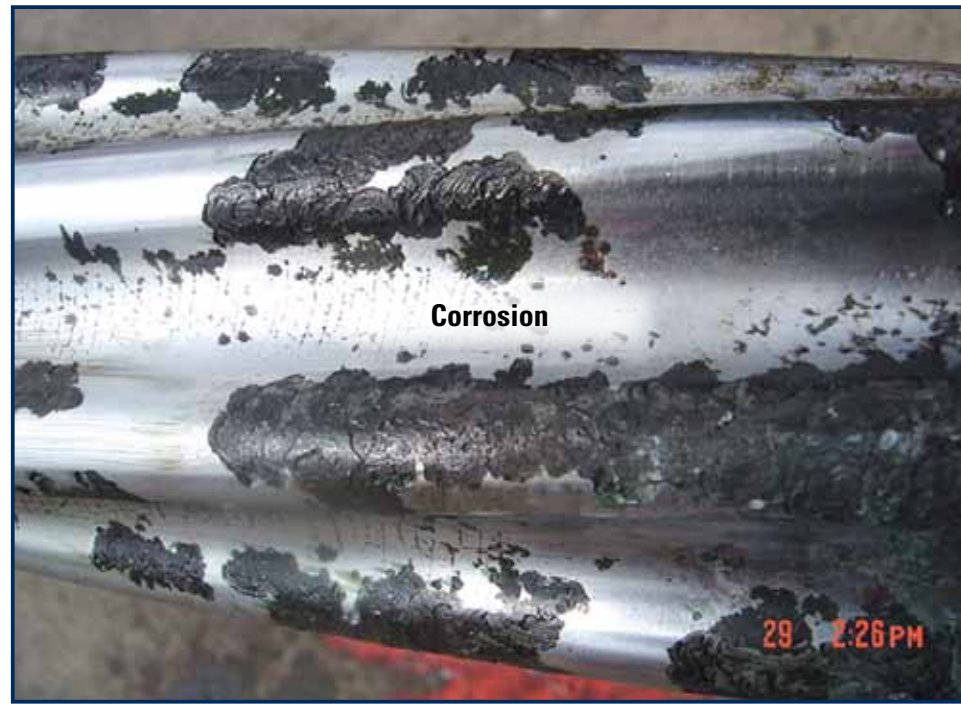
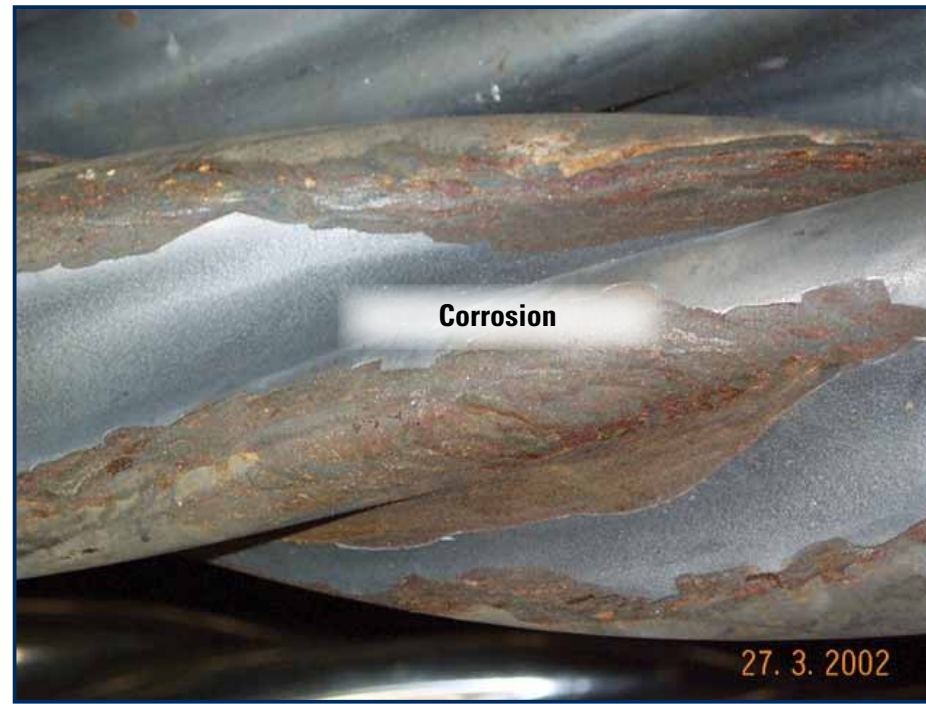
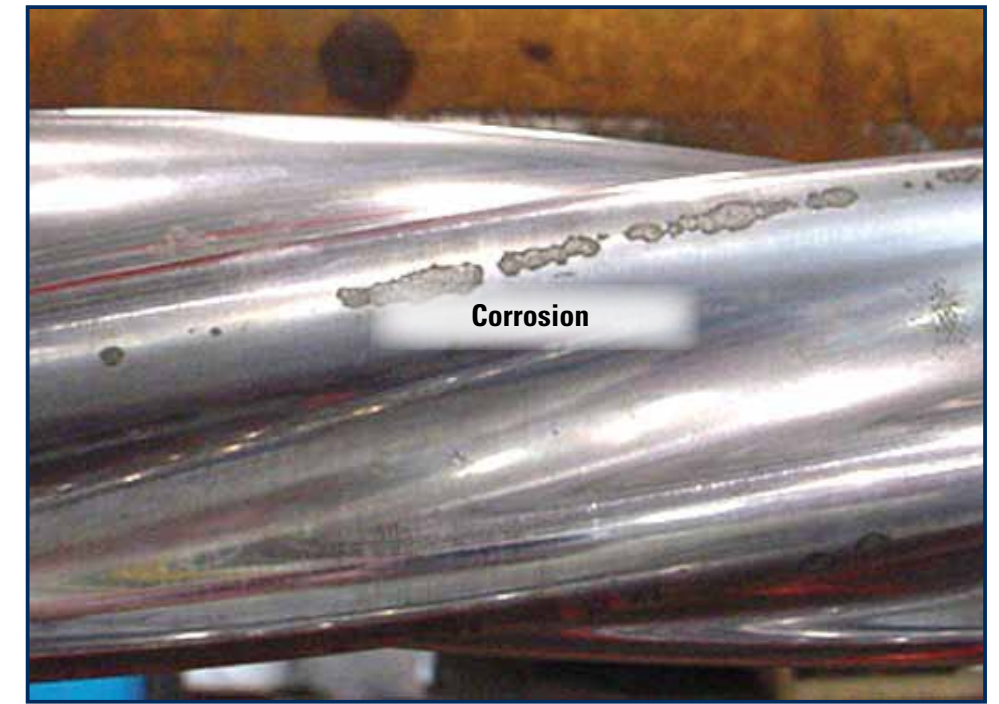
Corrosion Corrosion Corrosion

The failure of the coating due to corrosive elements in the drilling fluid. The fluid permeates the coating, and attacks the interface between the coating and base metal, causing the coating to peel or flake off.

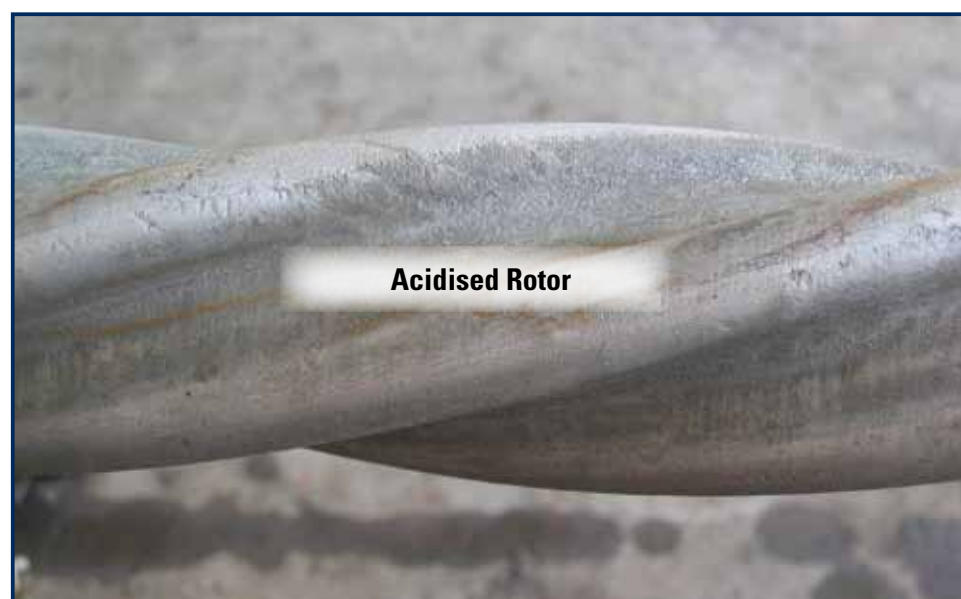
Acidised Rotor

Applications using high concentrations of hydrochloric acid will strip the chrome off the rotor, exposing the base metal.

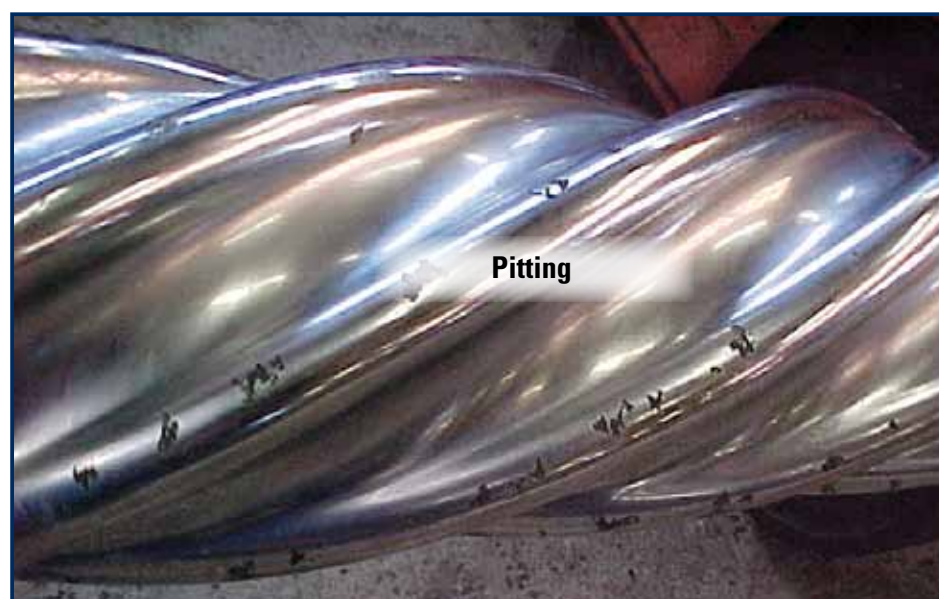
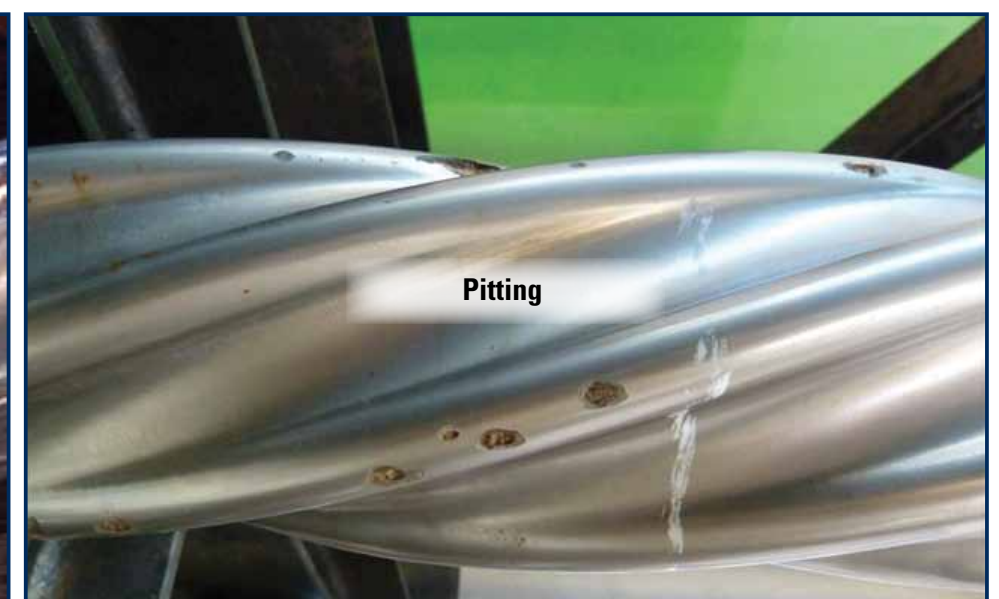
Pitting

The resulting damage on the base metal from corrosion attacks.

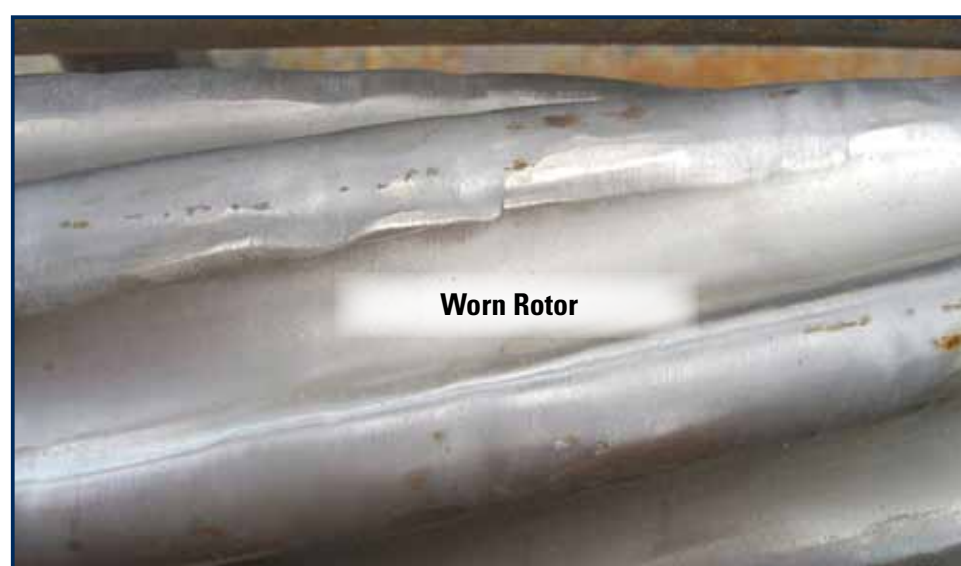
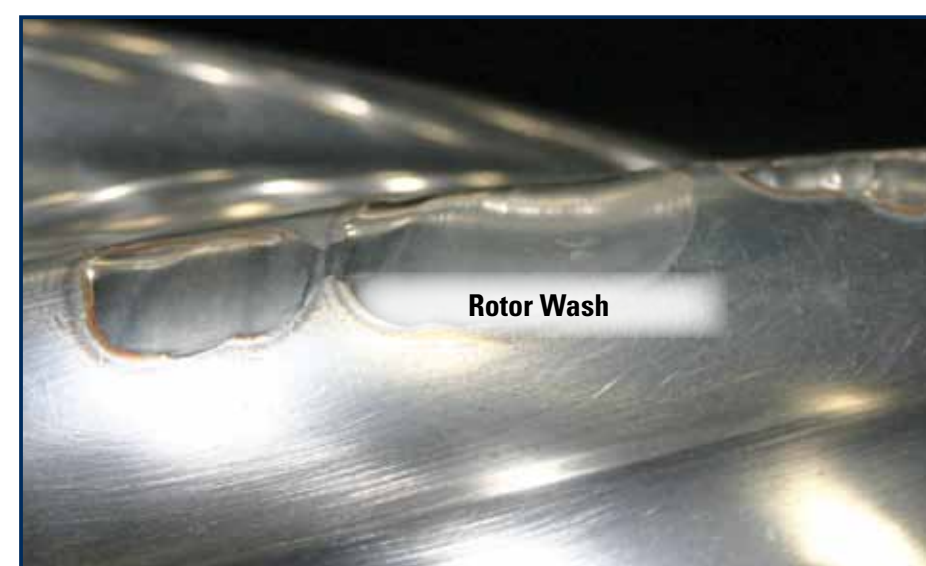
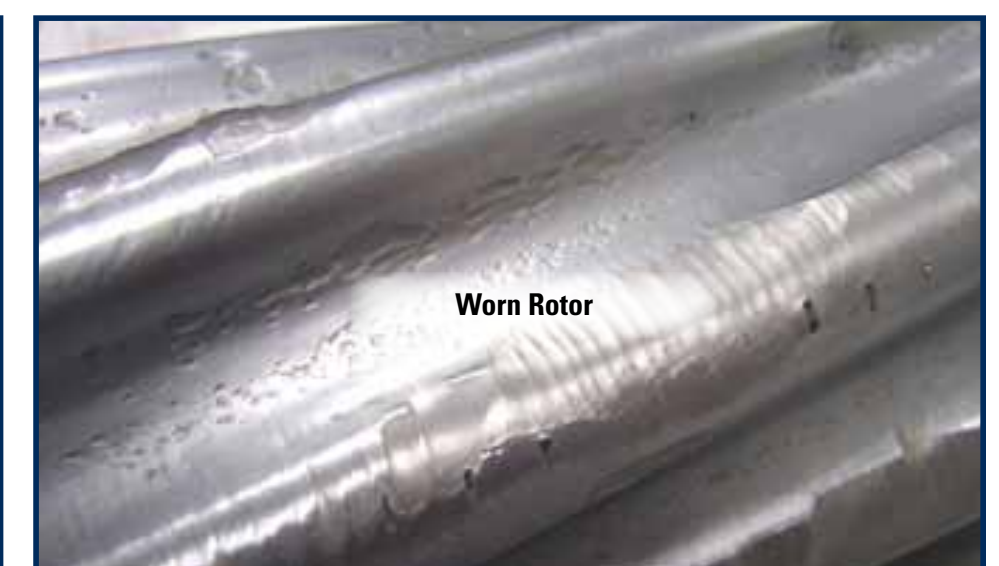
Rotor Wear Rotor Wear Rotor Wear

Any type of action or activity on the rotor which fundamentally alters the shape of the rotor profile.

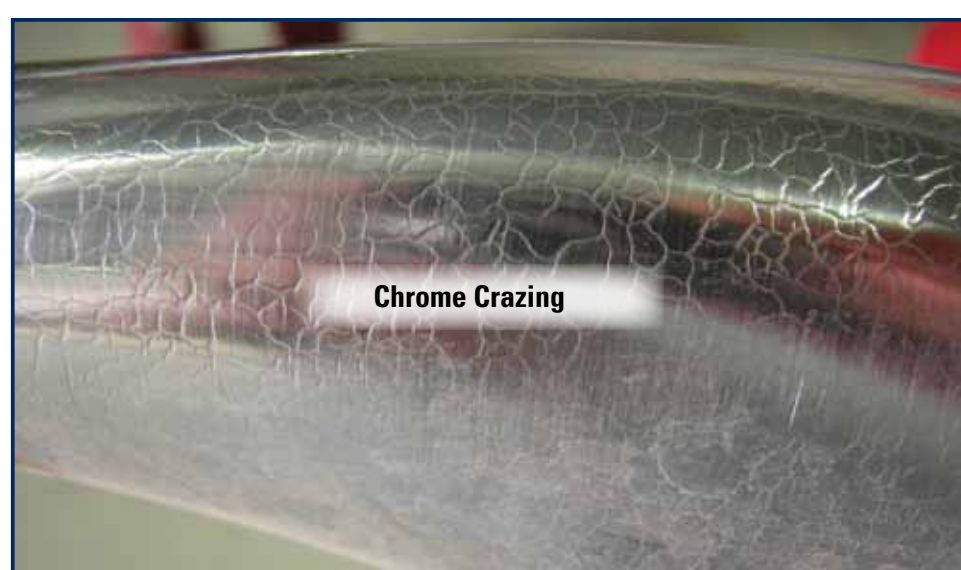
Chrome Crazeing

Amplification of the natural cracks in the chrome plating due to being subjected to high temperatures.

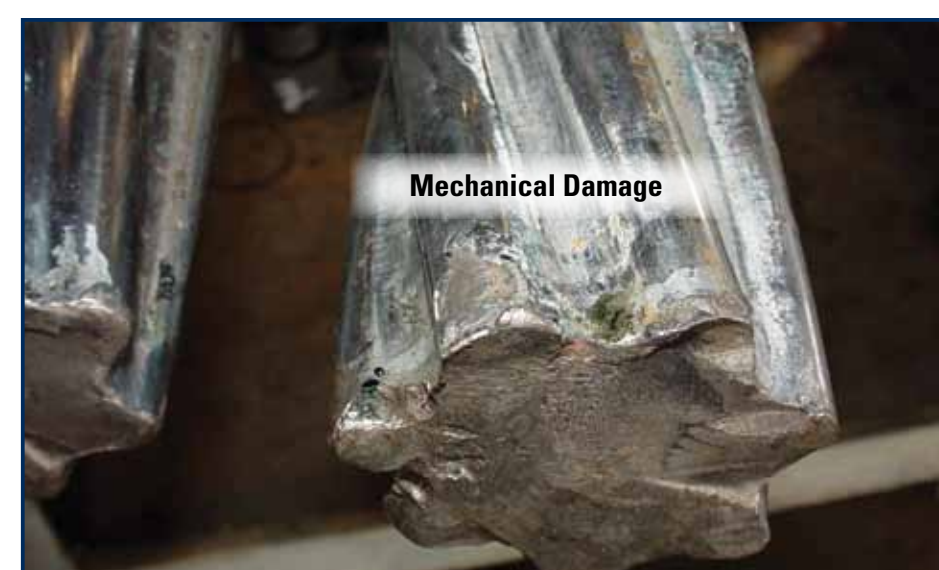
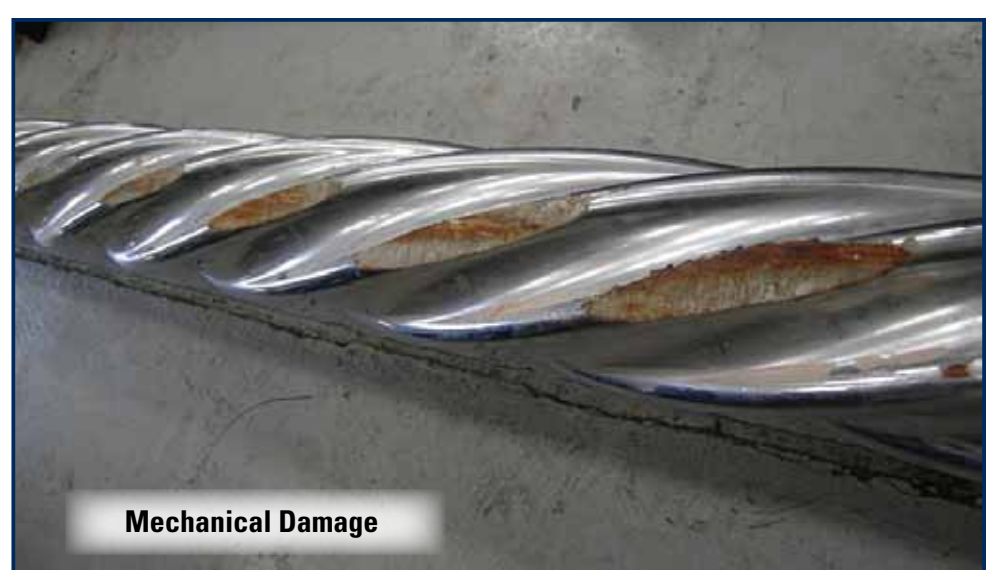
Mechanical Damage

Fatigue damage from excessive bending or damage occurred by foreign objects being pumped through the power section.
